TABLE OF CONTENTS

INTRODUCTION

PURPOSE AND OBJECTIVES OF THE MASTER PLAN

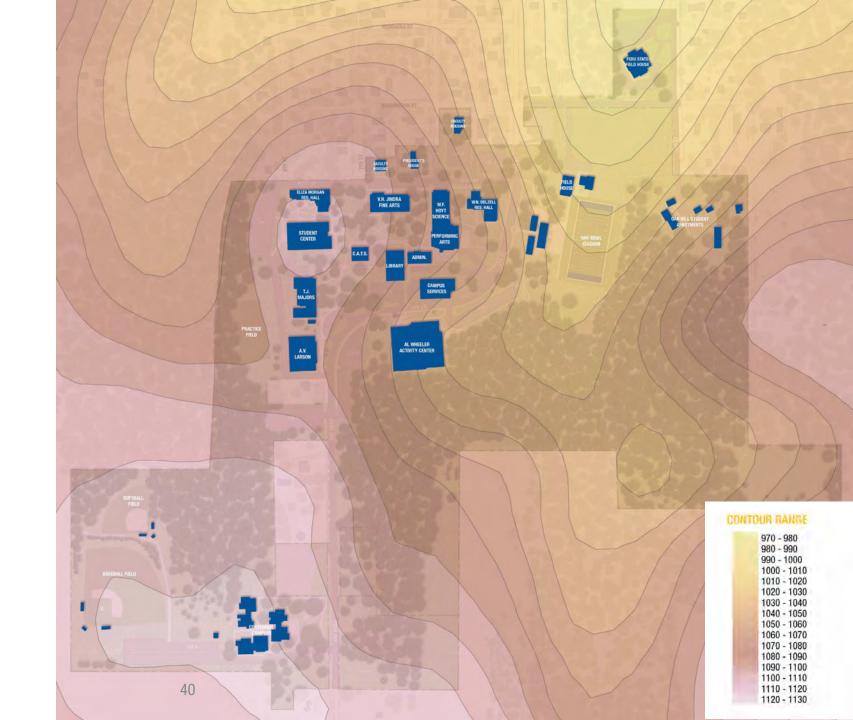
TOPOGRAPY

The campus resides on the ridge of two ravines. Topography across the main campus area is about 70-90 feet in grade change, with the highest point being the Student Center and the lowest at the Field House and the Oak Bowl. The Centennial Complex rests at the same high elevation as the Student Center and is relatively flat across the entire complex.

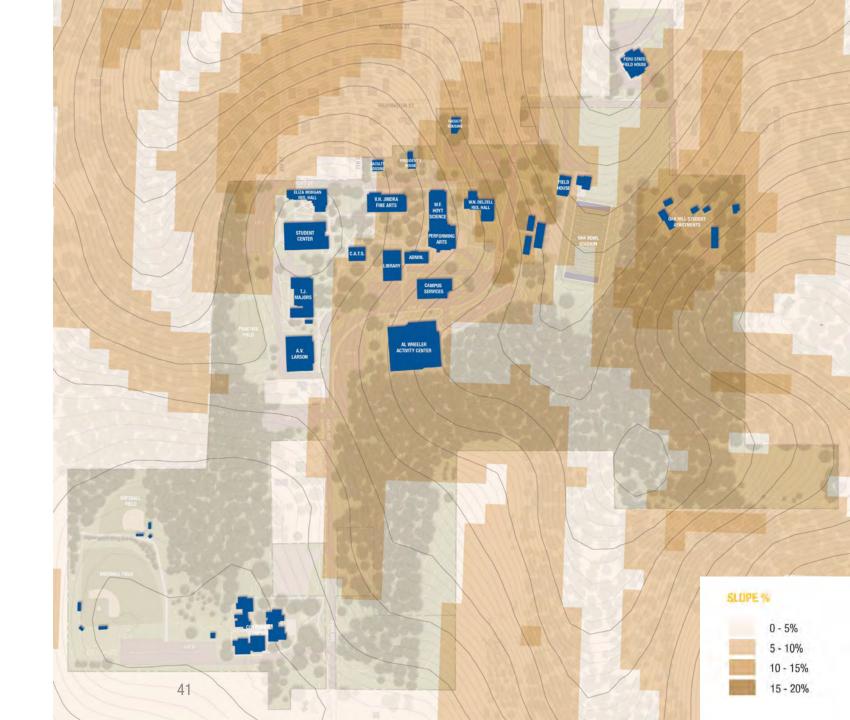
SLOPE

Slopes across the main campus are moderate to steep. The Student Center is located at the high point of campus. Grade drops rather quickly as one moves to the east. This creates challenges for accessibility, requiring the use of stairs and ramps. Each project that addresses site access needs to consider how accessibility will be addressed.

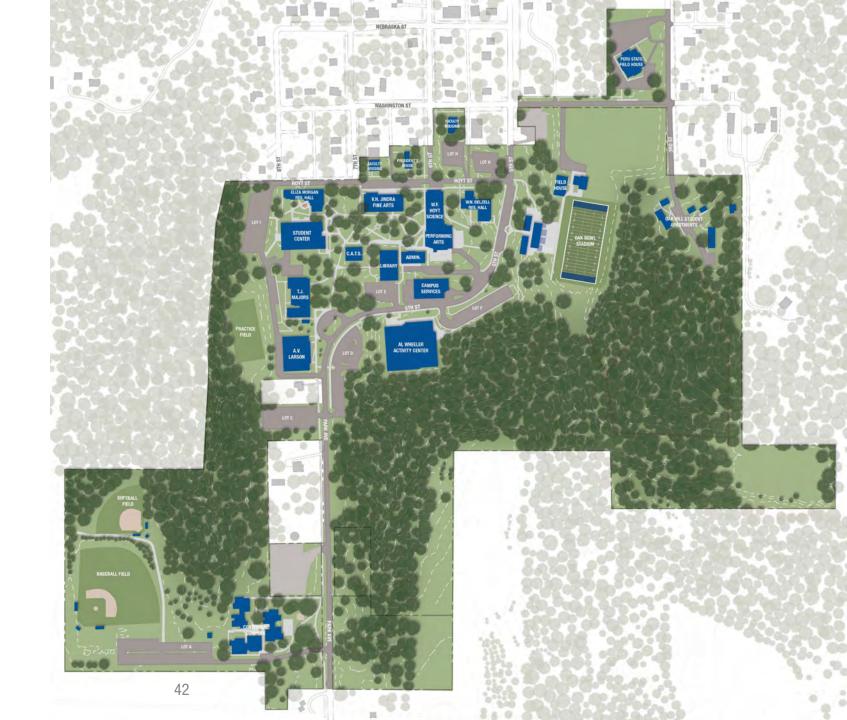
FLOODWAY

There are no surveyed or jurisdictional floodways on the current campus. The steep topography and ravines located on the east and west side of campus do create opportunities for flash floods in heavy rains.

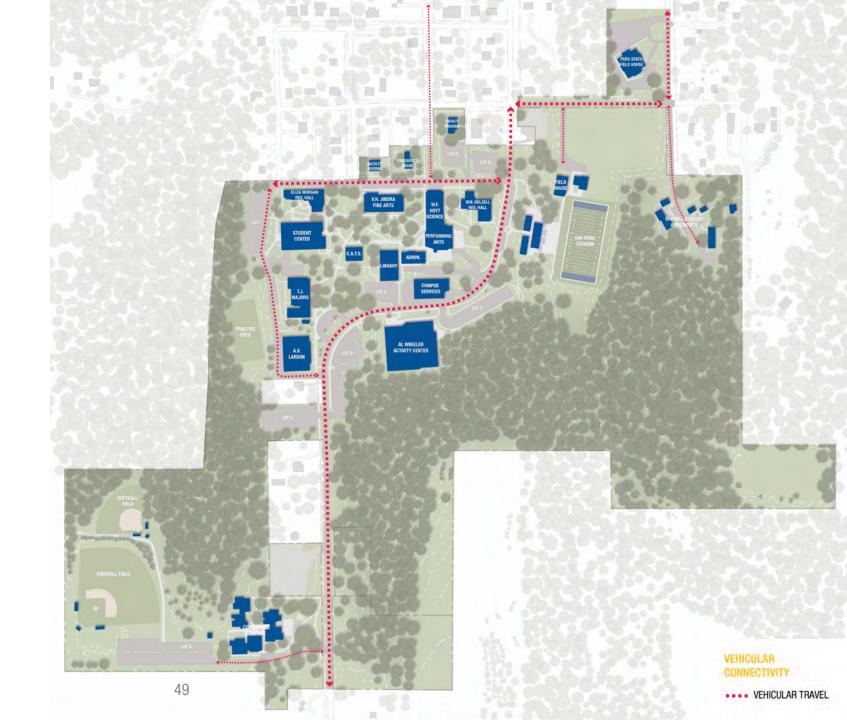
Vehicular access to and from campus is primarily from Park Avenue as one comes off Highway 67, south of campus. Park Avenue turns in to 5th Street and continues around the south and east side of campus, before heading into downtown Peru.

The Master Plan recommends streetscape, lighting and pedestrian circulation improvements along 5th Street, Hoyt Street, and Washington Street.

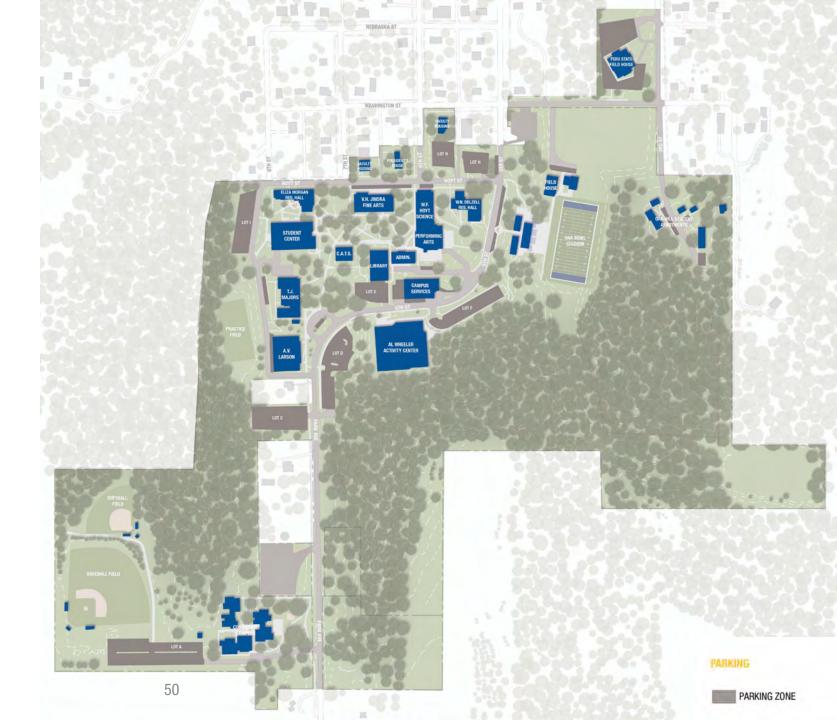
PARKING

All but one parking lot is accessible from Park Avenue/5th Street (Lot I) making access to parking simple. Parking quantities are generally good, but some are a bit far from main campus. People parking in Lots B & C have further to walk. The parking lots are in average condition, but several are gravel and should be repaved with concrete. Other lots are showing their age and should be repaved and enhanced within the next 10 years.

The Master Plan recommends repaving all gravel lots and drives with concrete and for the College to systematically begin to repave all the lots, starting with those paved with asphalt.

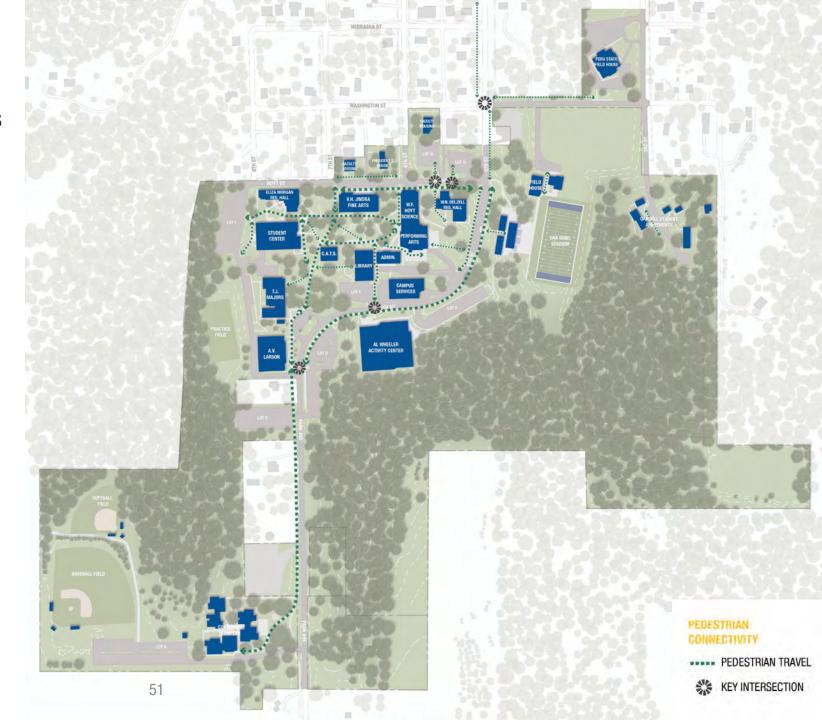
CIRCULATION - PEDESTRIAN

The Master Plan recommends improvements in campus pedestrian lighting.

The Master Plan recommends maintaining the interior circulation of campus in its current state but widening all primary walks to a standard 8-foot width and all secondary walks to a 6-foot width. Walks should be primarily of concrete construction with specialty pavement at key locations. See the Detailed Landscape Master Plan for more information.

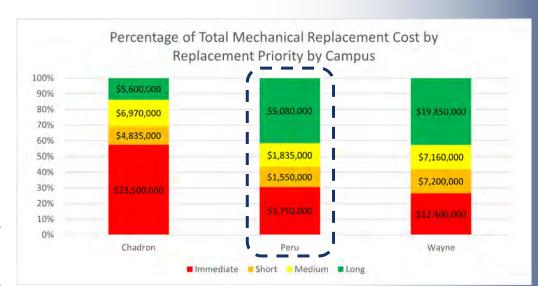
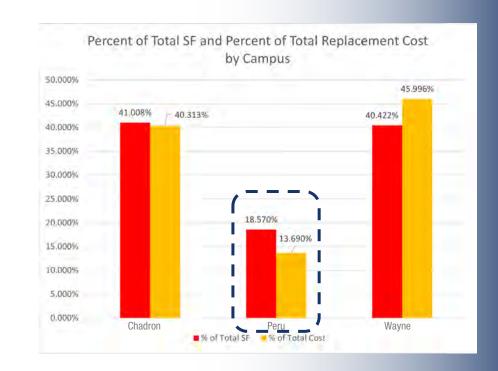
The charts at right compare Peru State to its sister colleges in the Nebraska State College System.

- When looking at all the colleges, Peru State has the second lowest need for equipment to be replaced immediately in terms of percentage of the campus total. (Top chart)
- The total square foot by campus chart (bottom right) is provided to help discern why one campus might be smaller in cost than the others.
- All costs used in this portion of the Master Plan are from RS Means 2020 and AES Historical Data along with an additional 30% added to account for current supply chain issues due to the COVID-19 pandemic.

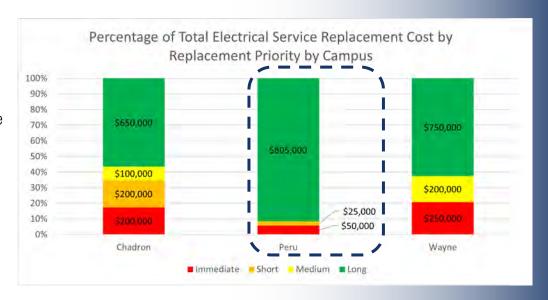
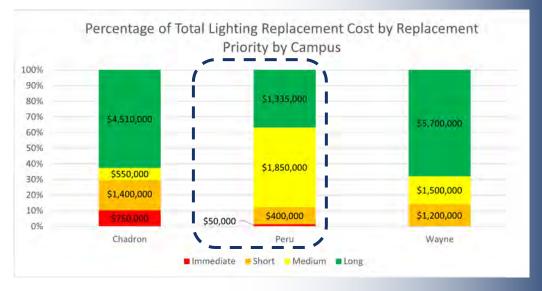
The included charts compare Peru State to its sister colleges in the Nebraska State College System.

- When looking at all the colleges, Peru State has the lowest need for electrical service equipment to be replaced immediately.
- All prices used in this portion of the Master Plan are from RS Means 2020 and AES Historical Data along with an additional 30% added to account for current supply chain issues due to the COVID-19 pandemic.

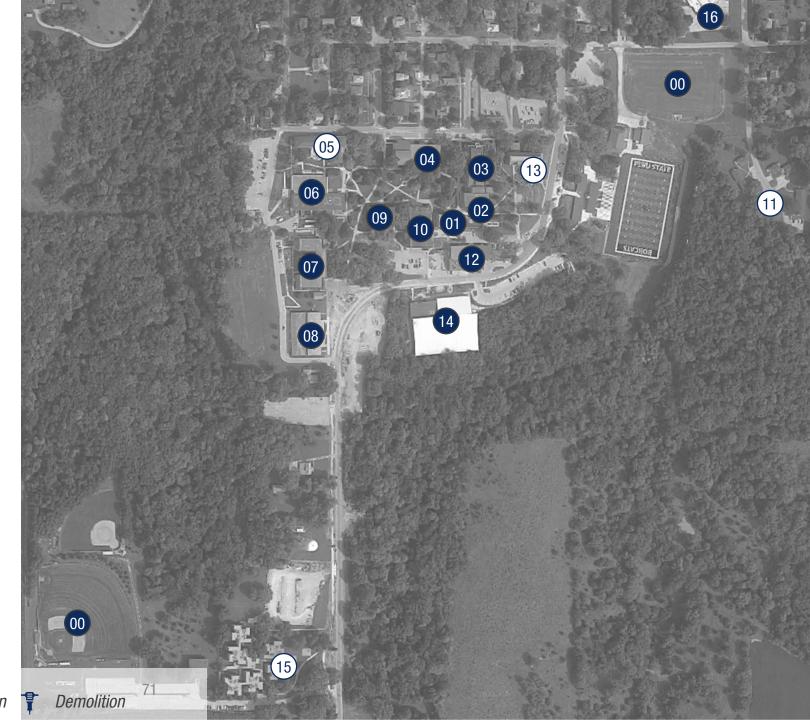
Recommendations: Campus & Site Master Plan

Facilities Master Plan 血 **00**: Indoor Rec/Athletic Complexes **01:** Administration Building **02:** Performing Arts Center 03: W.F. Hoyt Science Building **04:** V.H. Jindra Fine Arts Building **05:** Eliza Morgan Hall **06:** Student Center **07:** T.J. Majors **08:** A.V. Larson **09:** CATS (Center for Achievement & Transition Services) **10:** Library 11: Oak Hill Apts (Faculty Housing) **12:** Campus Services 13: W.N. Delzell Hall 14: Al Wheeler Activity Center **15:** Centennial Complex **16:** Field House Peru m New Building > Renovation Addition

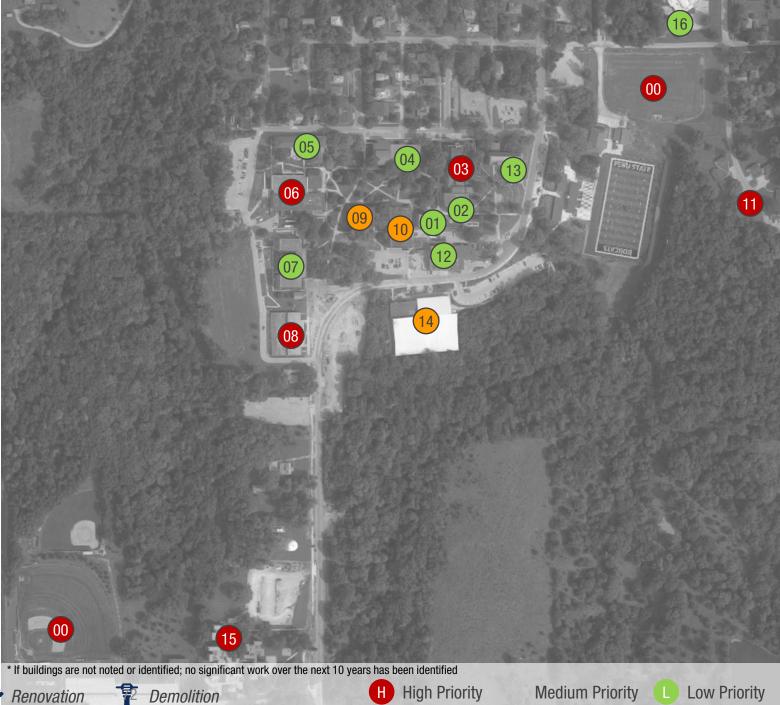
Facilities Master Plan **H** 00: Indoor Rec/Athletic Complexes 皿 **01:** Administration Building **02:** Performing Arts Center 03: W.F. Hoyt Science Building **04:** V.H. Jindra Fine Arts Building **05:** Eliza Morgan Hall
